Manhole Inspection Summary

Manhole # S37C1_002MH

Insp Date: **12/8/08 12:17 PM**

Location Address: **e. cromwell st**

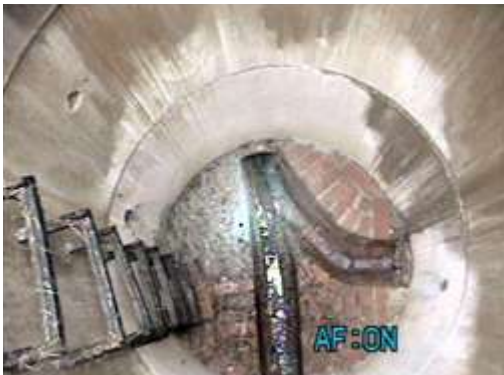
Defect 2

Infiltration: ☐ None ☒ **Joint** ☐ Cracks ☐ Mortar ☐ Roots ☐ Wall

Chimney and corbel joint infiltration

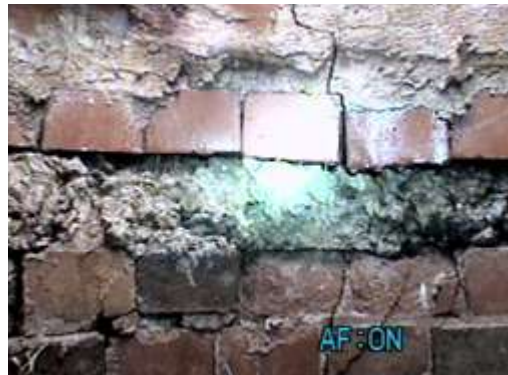
Defect 1

Condition: ☐ Sound ☒ **Cracked** ☐ Root Intrusion ☒ **Loose Brick** ☒ **Deteriorated**

chimney deteriorated

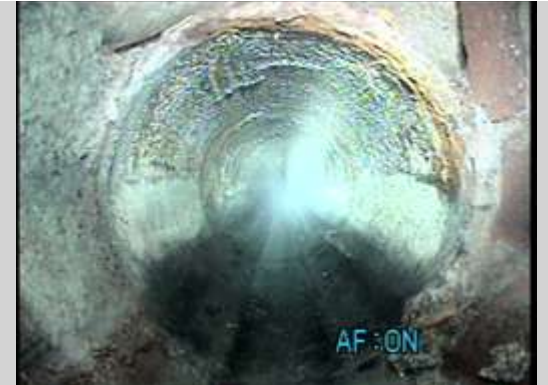
12 O'Clock Outflow

8 in. Circular Gravity Sewer
Pipe Out @ 12 O'Clock

Invert Depth: 11.66 (ft.) Flow Characteristics: **Slow**

Infiltration: **None** Pipe Seal Cond: **Unknown**

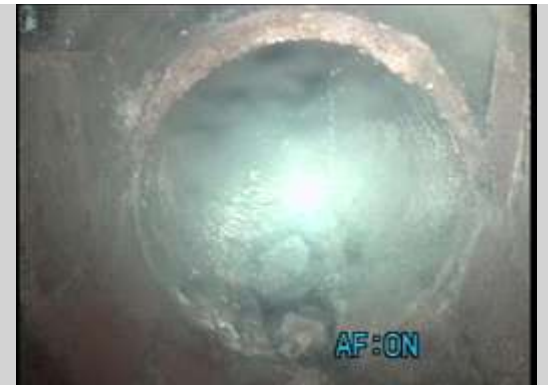
3 O'Clock Inflow

8 in. Circular Gravity Sewer
Pipe In @ 3 O'Clock

Invert Depth: 11.33 (ft.) Flow Characteristics: **None**

Infiltration: **None** Pipe Seal Cond: **Unknown**

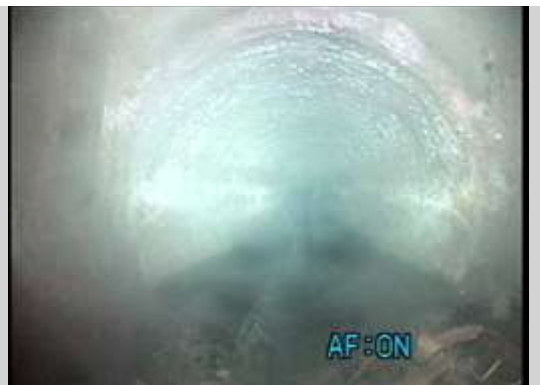
6 O'Clock Inflow

8 in. Circular Gravity Sewer
Pipe In @ 6 O'Clock

couldnt get better pic due to steam

Invert Depth: **11.54** (ft.) Flow Characteristics: **Slow**

Infiltration: **None**
